Site 15: Spring-Ford School District

BMPs:

- Basin Retrofit
- Rain Garden (proposed)
- Swale Buffers/Meadow areas

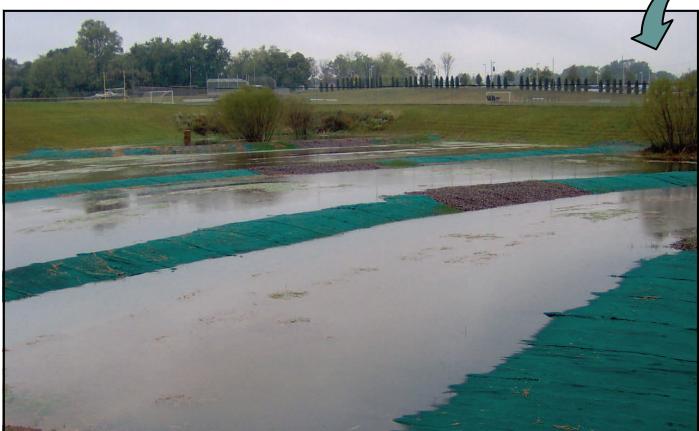
The photo shows the basin condition one year after implementation.

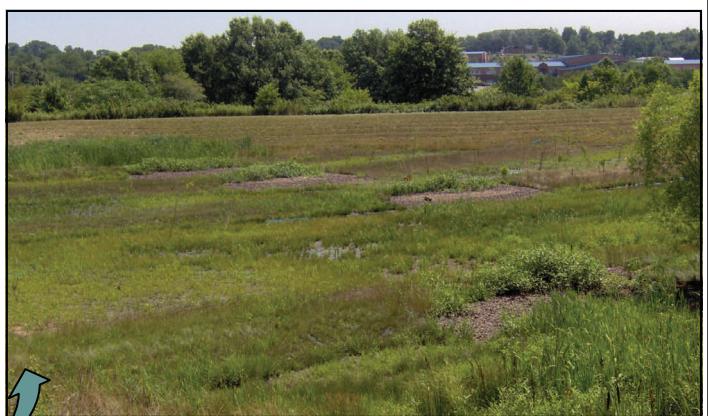
Taken shortly after construction the photo illustrates water quality berms providing stormwater retention.

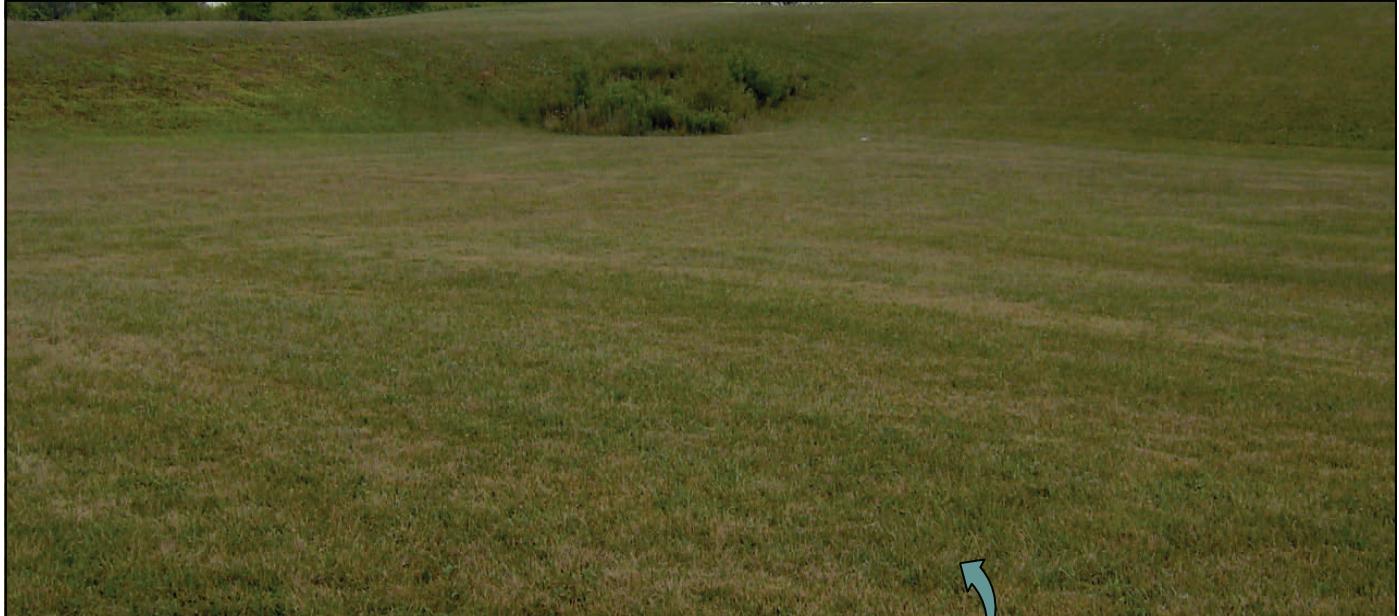
Pre-implementation Condition

Prior to the basin retrofit, the stormwater basin was managed as a mowed turf landscape. This type of management requires regular mowing. The shallow rooted turf does not maximize groundwater recharge capabilities. By converting the basin to meadow vegetation, the recharge capabilities improved by as much as 30% from a conventional turfgrass basin. Managing the basin in a meadow condition also allows for improved filtration of the stormwater runoff and increased evapotranspiration.
